Special Situation Report

U.S. Army Corps of Engineers
Omaha District

Low Dissolved Oxygen Levels in Summer Powerplant Discharges from Fort Randall Dam, South Dakota

Report Number: CENWO-ED-HA/SSR/Fort Randall Tailwaters/2010

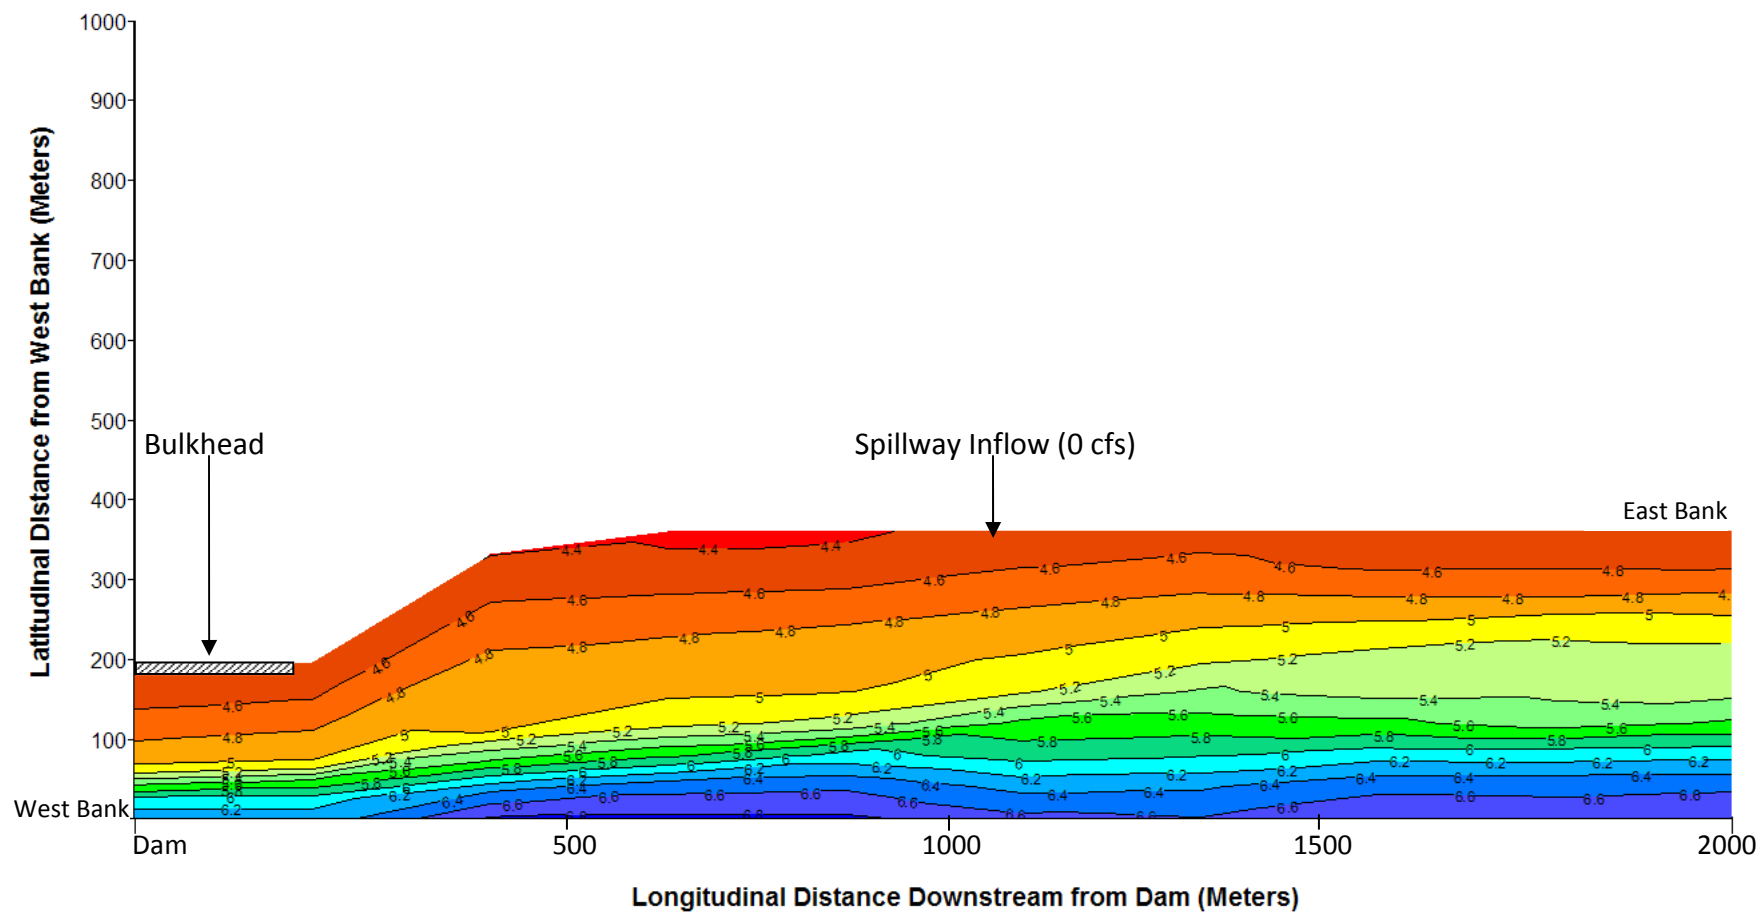
Figures 31, 32, and 33, respectively, display transect contour plots that were constructed to depict the dissolved oxygen concentrations measured across the Fort Randall Dam tailwaters at the near-dam (FTRTW3), spillway confluence (FTRTW2), and downstream (FTRTW1) sites on 10-August-2010. Figure 34 displays an aerial contour plot of the water-column average dissolved oxygen concentrations in the tailwaters based on the 1-meter incremental depth-profile measurements.

Figure 34. Contour plot of average water-column dissolved oxygen concentrations for the Fort Randall Dam tailwaters on August 10, 2010. Water-column average based on 1-meter depth-profile dissolved oxygen measurements taken at the near-dam, spillway confluence, and downstream transects. Plot is an aerial view from above with the dam to the left, flow going to the right, west bank on the bottom, and the east bank on the top (see Figure 18 for an aerial photo of the area).

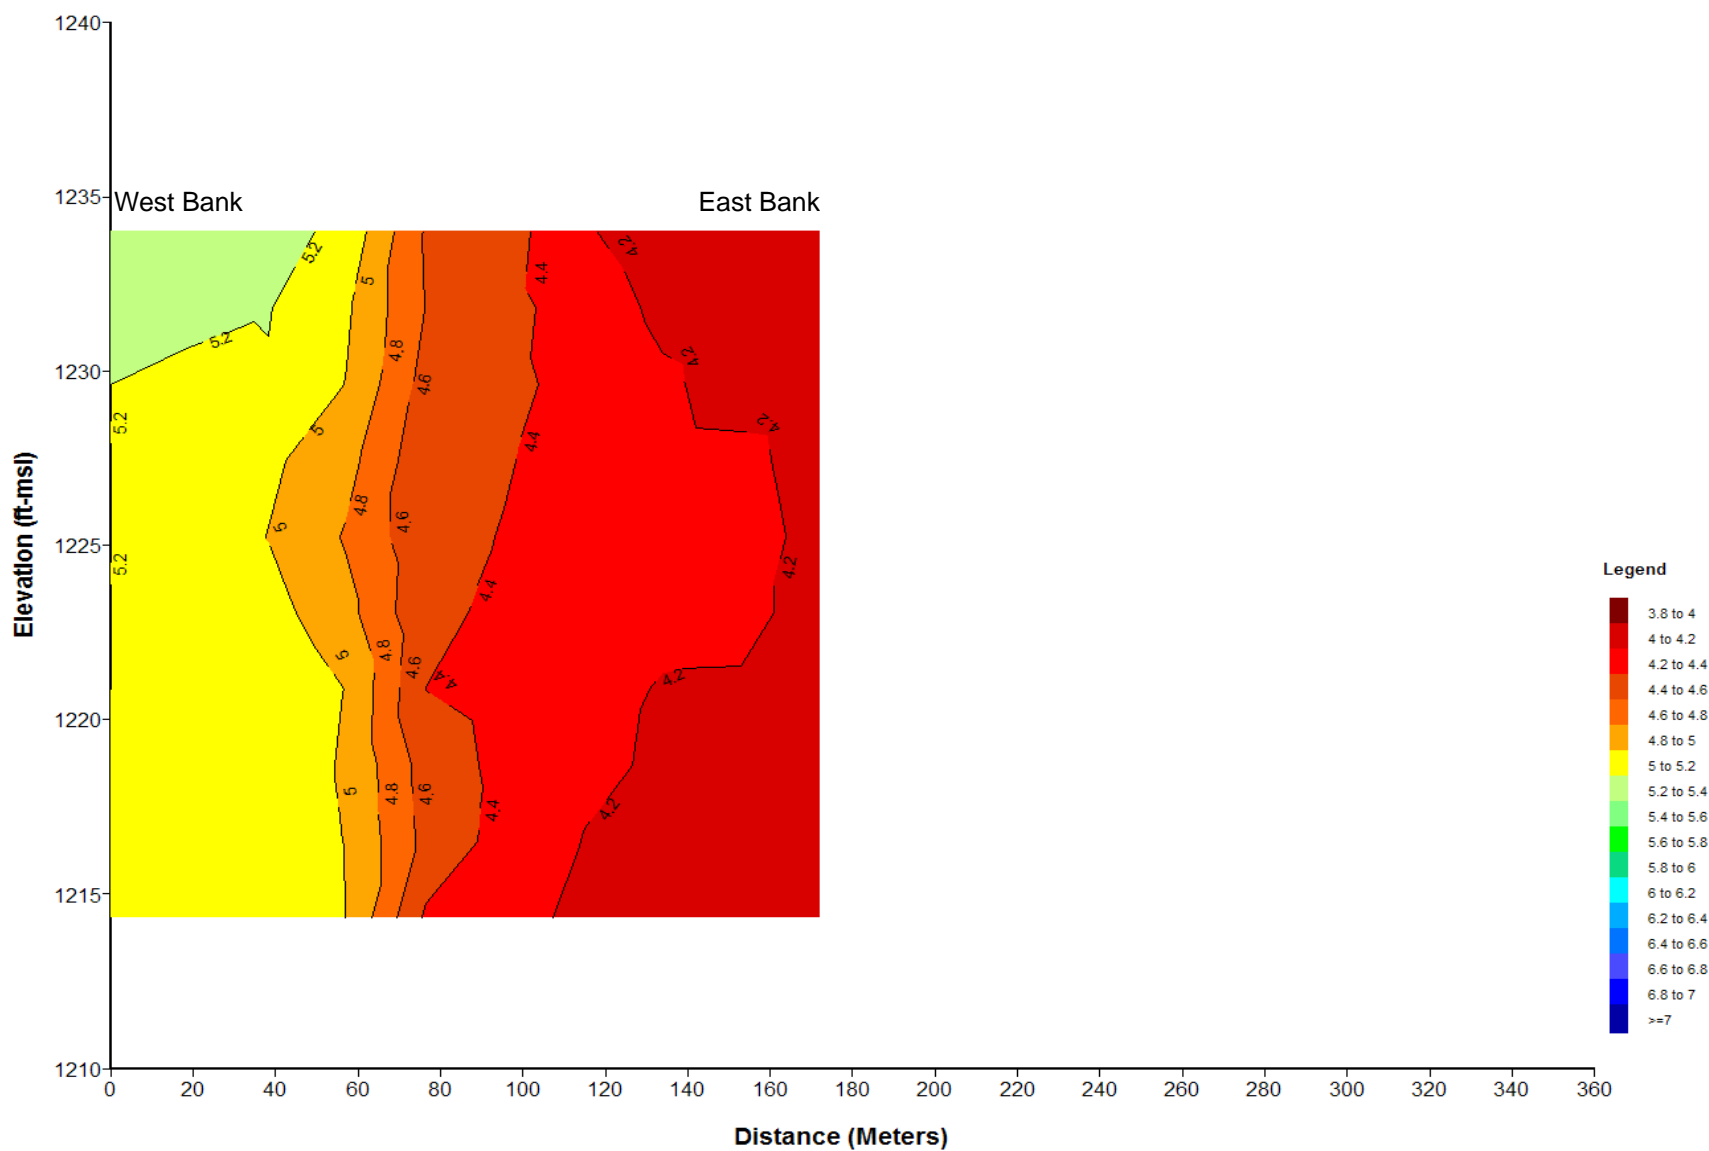
Figures 35, 36, and 37, respectively, display transect contour plots that were constructed to depict the dissolved oxygen concentrations measured across the Fort Randall Dam tailwaters at the near-dam (FTRTW3), spillway confluence (FTRTW2), and downstream (FTRTW1) sites on 12-August-2010. Figure 38 displays an aerial contour plot of the water-column average dissolved oxygen concentrations in the tailwaters based on the 1-meter incremental depth-profile measurements.

Figure 35. Contour plot depicting dissolved oxygen concentrations measured across the near-dam transect (FTRTW3) on August 12, 2010.

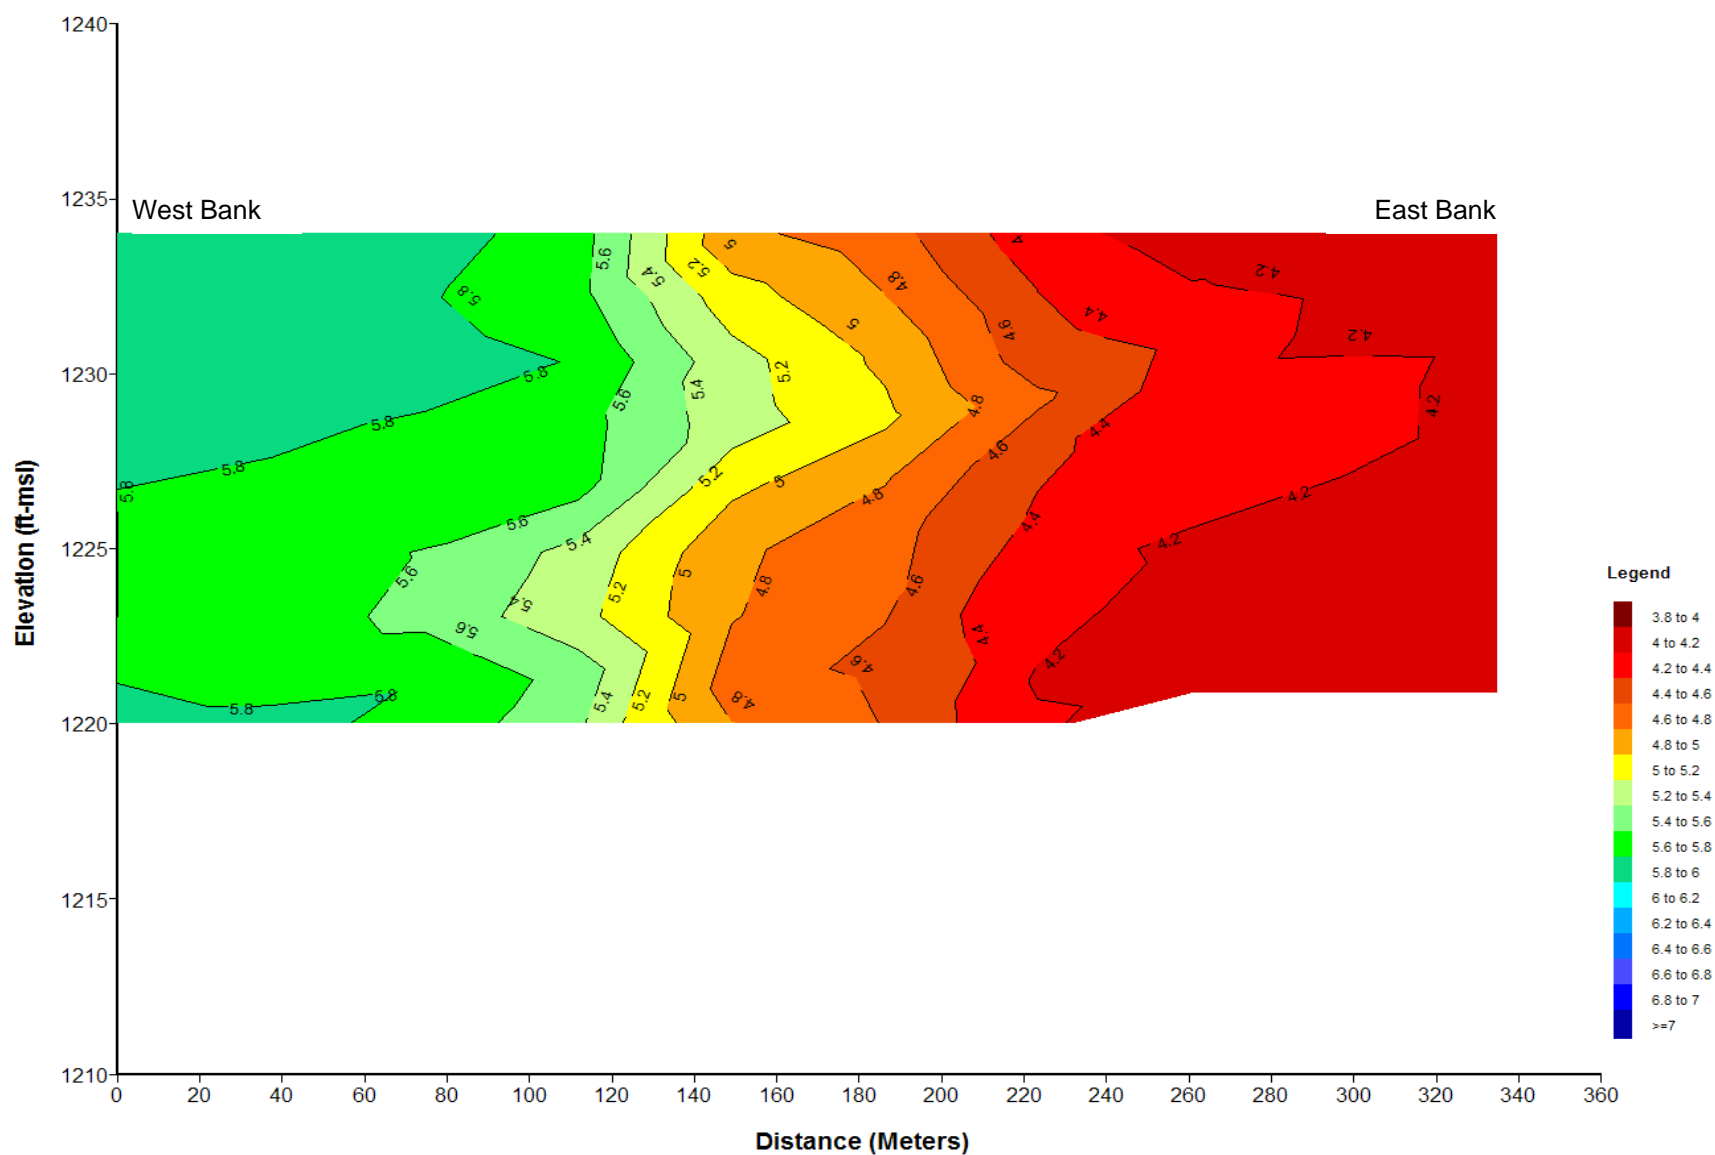
Figure 36. Contour plot depicting dissolved oxygen concentrations measured across the spillway transect (FTRTW2) on August 12, 2010.

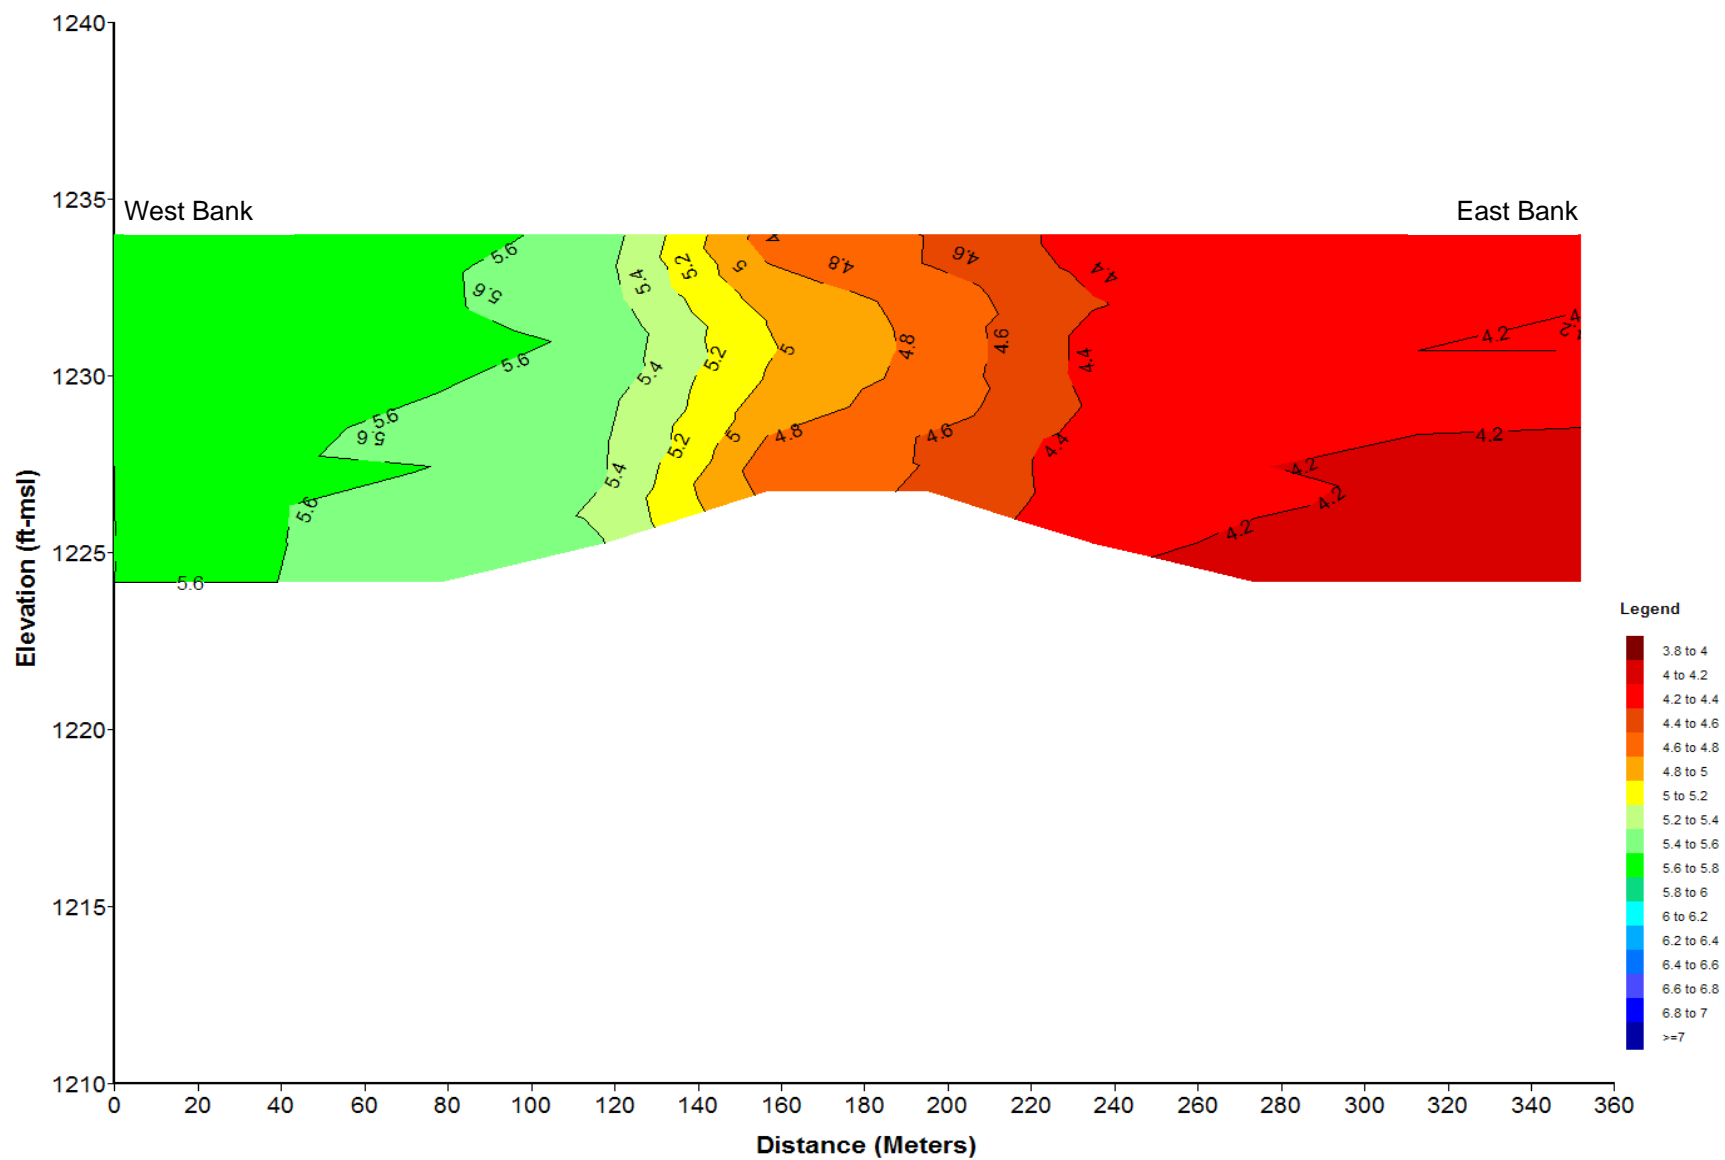
Figure 37. Contour plot depicting dissolved oxygen concentrations measured across the downstream transect (FTRTW1) on August 12, 2010.

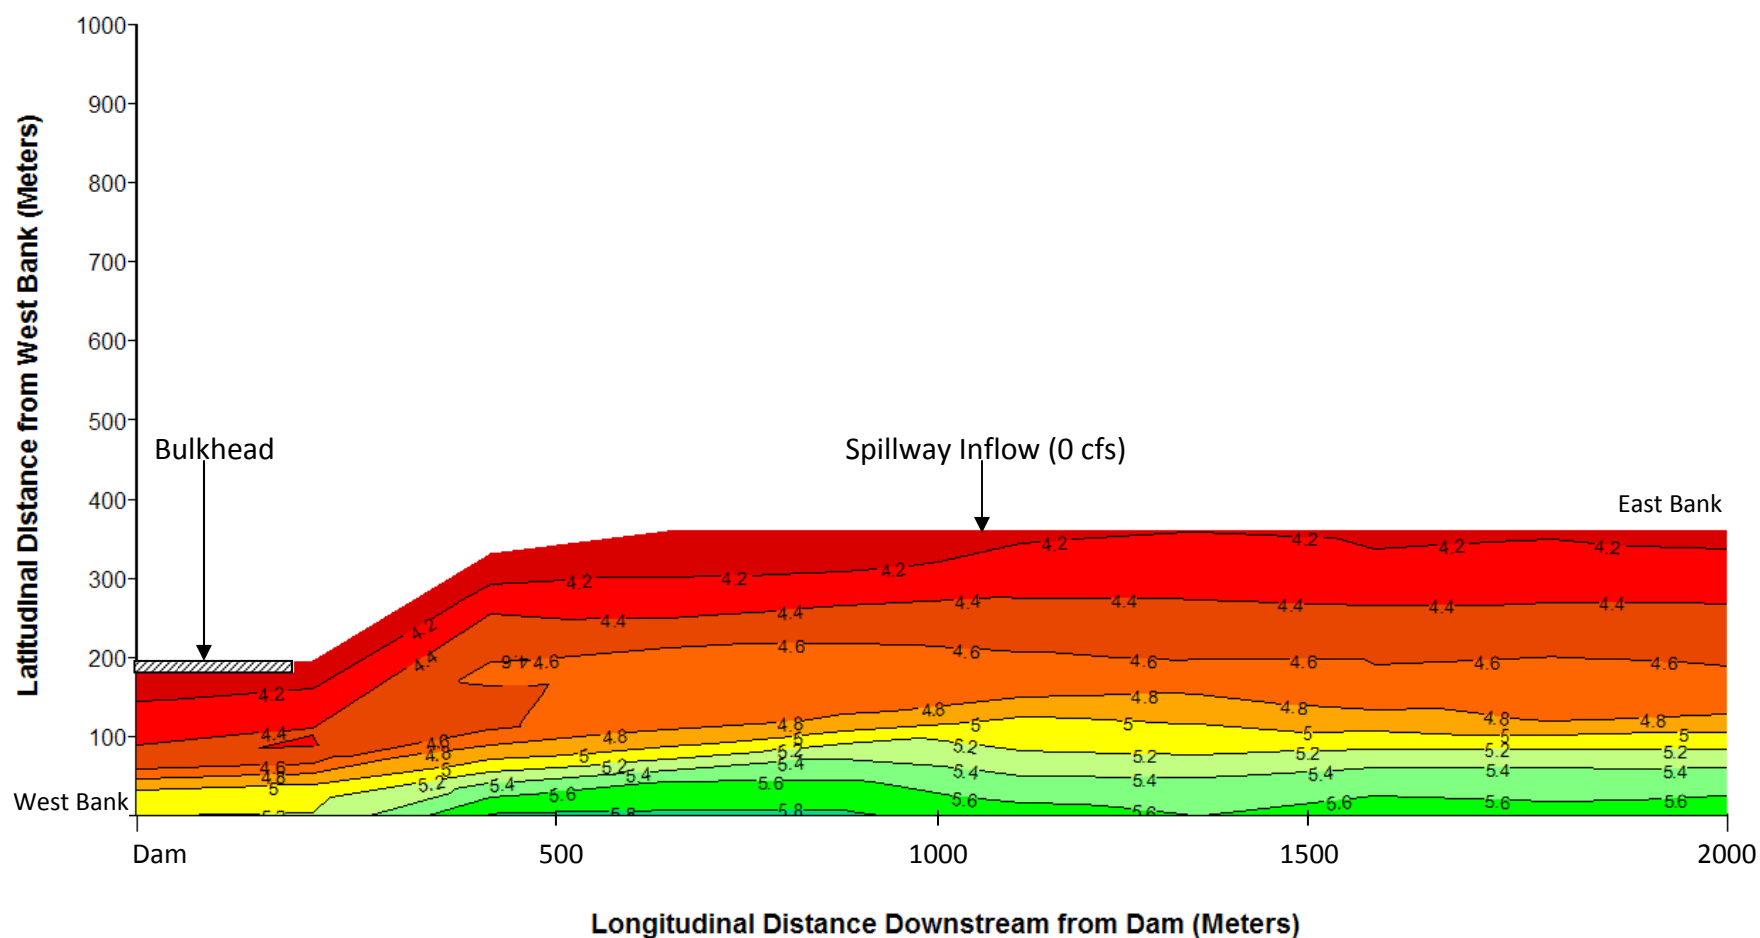
Figure 38. Contour plot of average water-column dissolved oxygen concentrations for the Fort Randall Dam tailwaters on August 12, 2010. Water-column average based on 1-meter depth-profile dissolved oxygen measurements taken at the near-dam, spillway confluence, and downstream transects. Plot is an aerial view from above with the dam to the left, flow going to the right, west bank on the bottom, and the east bank on the top (see Figure 18 for an aerial photo of the area).

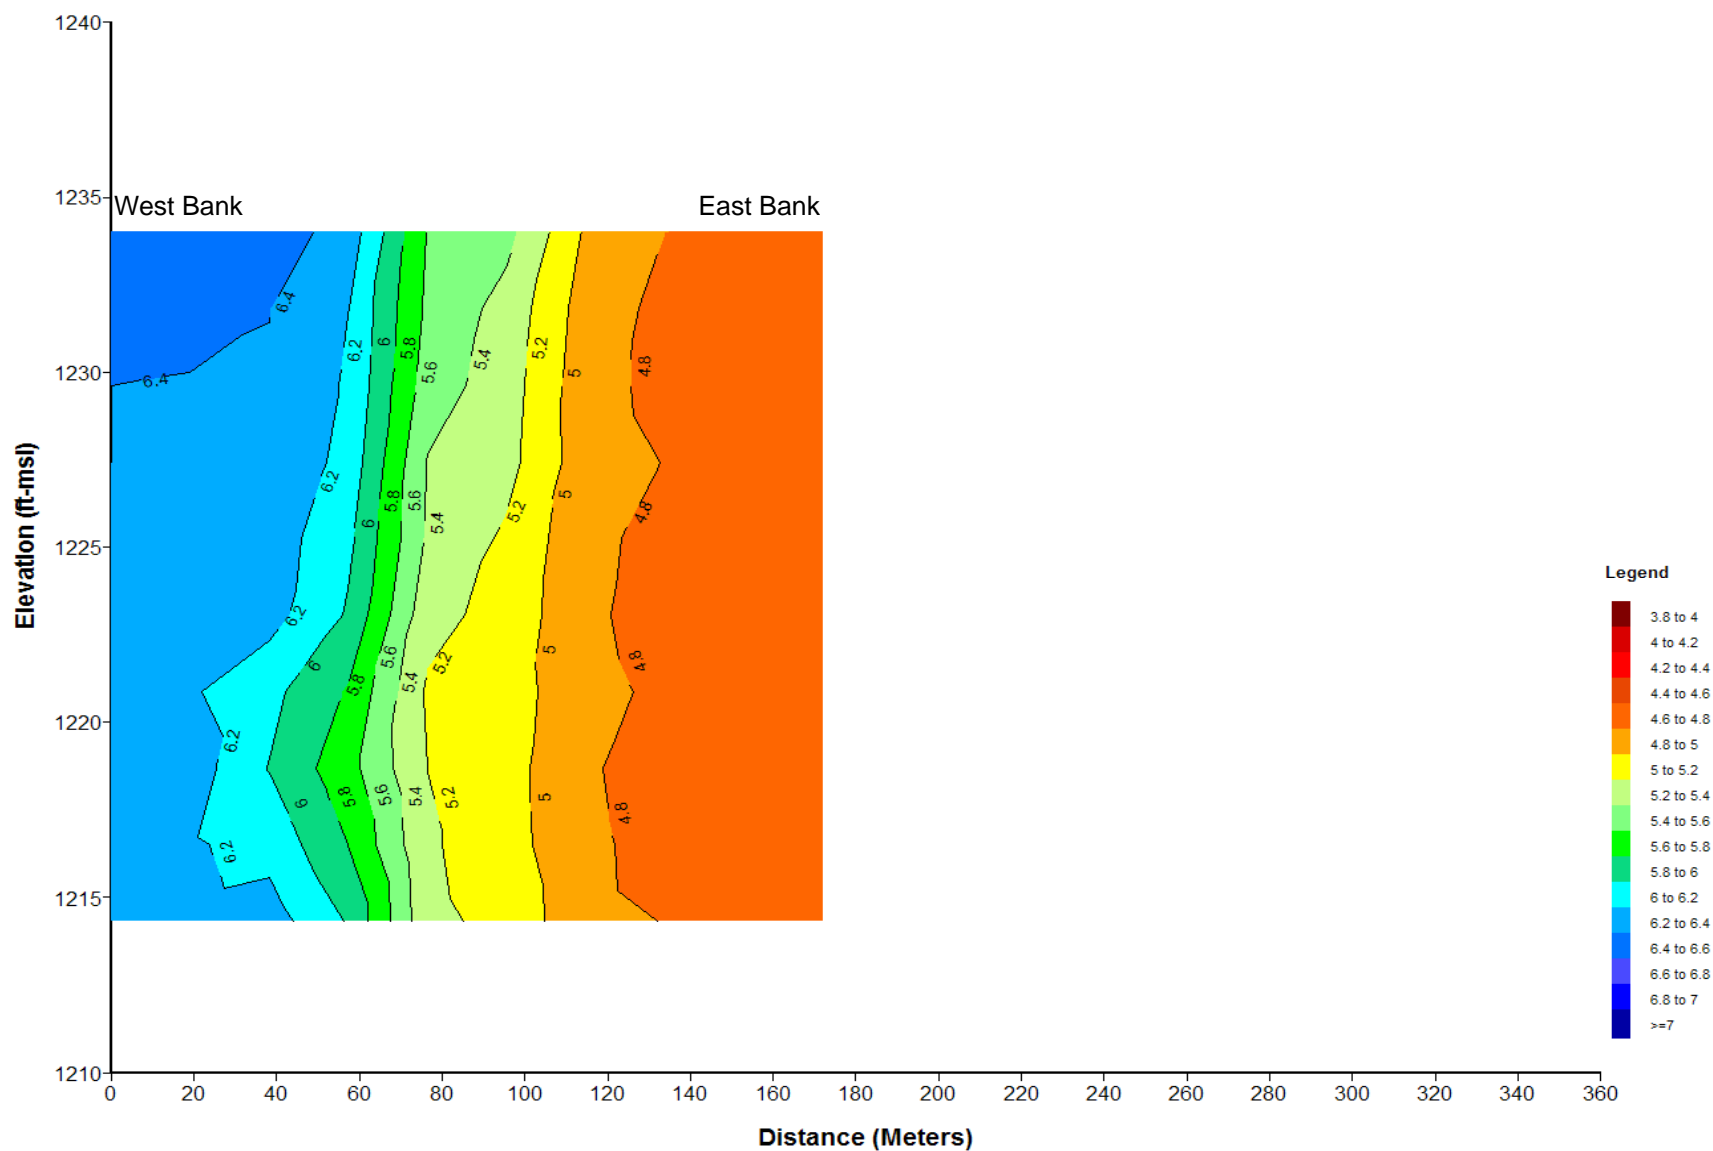
Figures 39, 40, and 41, respectively, display transect contour plots that were constructed to depict the dissolved oxygen concentrations measured across the Fort Randall Dam tailwaters at the near-dam (FTRTW3), spillway confluence (FTRTW2), and downstream (FTRTW1) sites on 17-August-2010. Figure 42 displays an aerial contour plot of the water-column average dissolved oxygen concentrations in the tailwaters based on the 1-meter incremental depth-profile measurements.

Figure 39. Contour plot depicting dissolved oxygen concentrations measured across the near-dam transect (FTRTW3) on August 17, 2010.

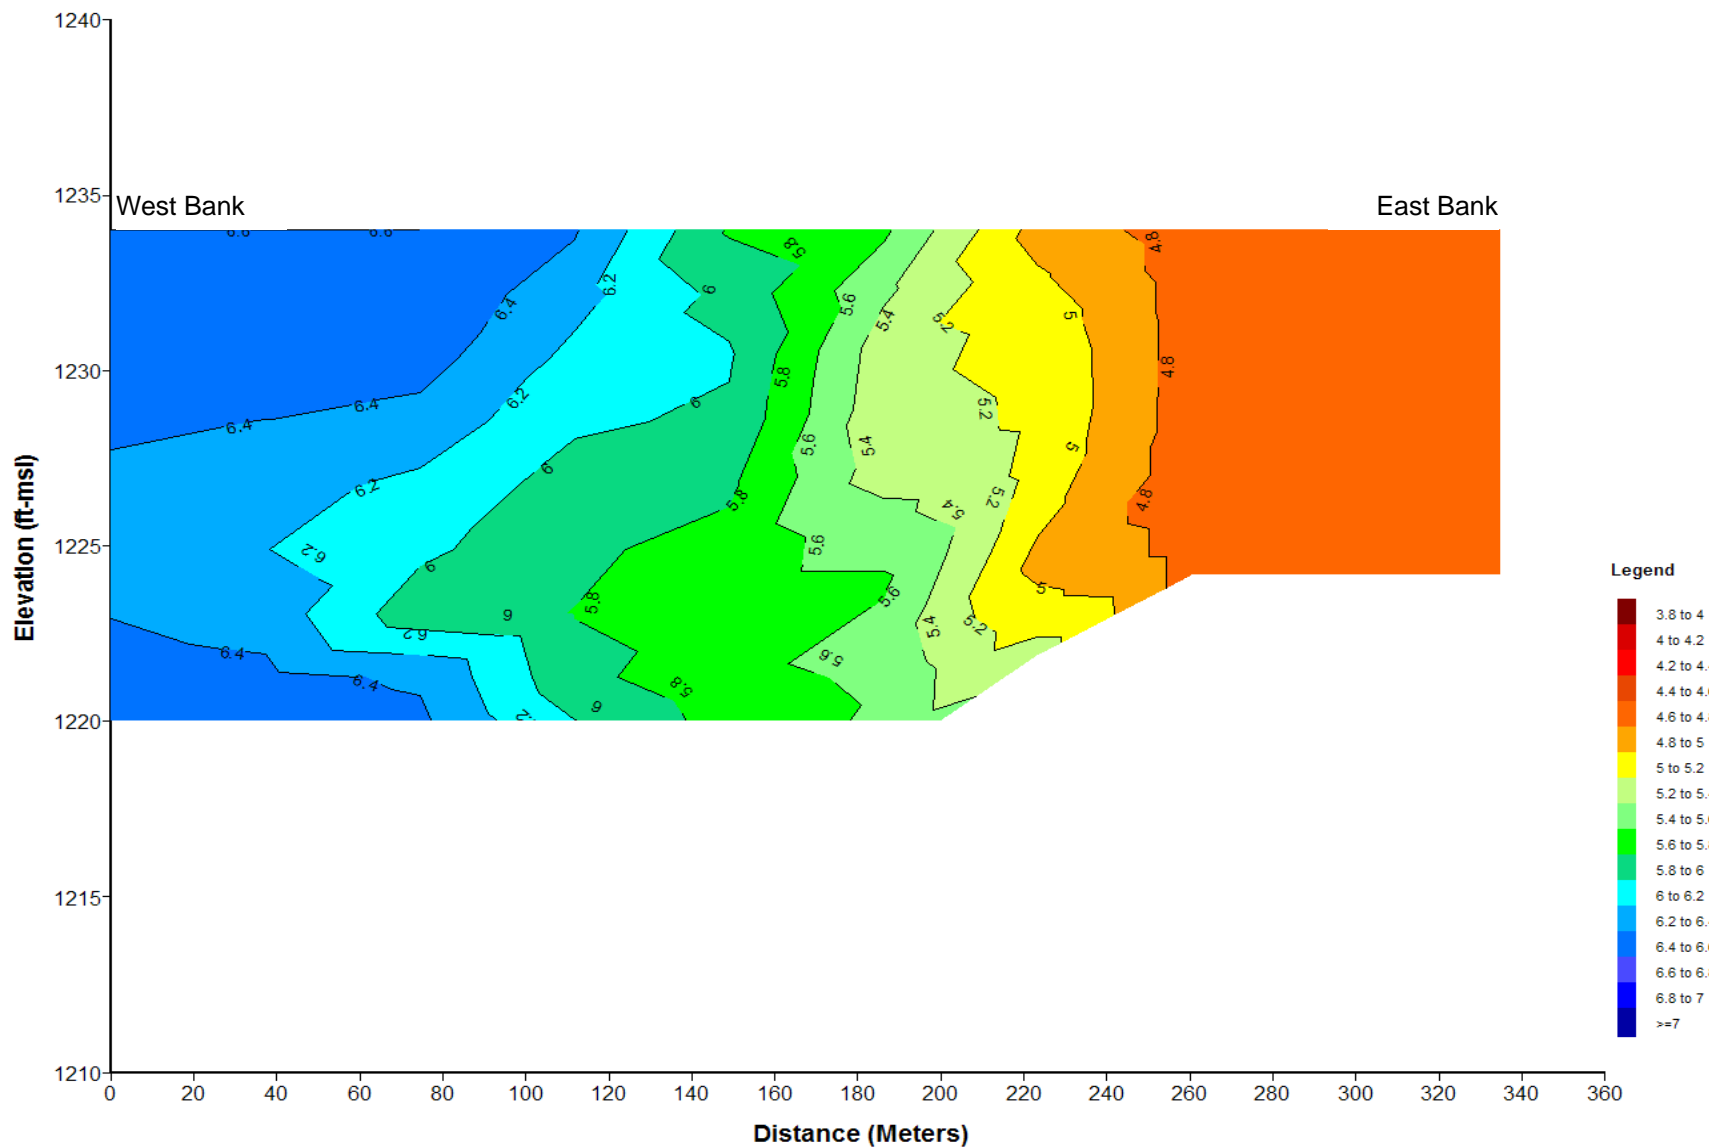
Figure 40. Contour plot depicting dissolved oxygen concentrations measured across the spillway transect (FTRTW2) on August 17, 2010.

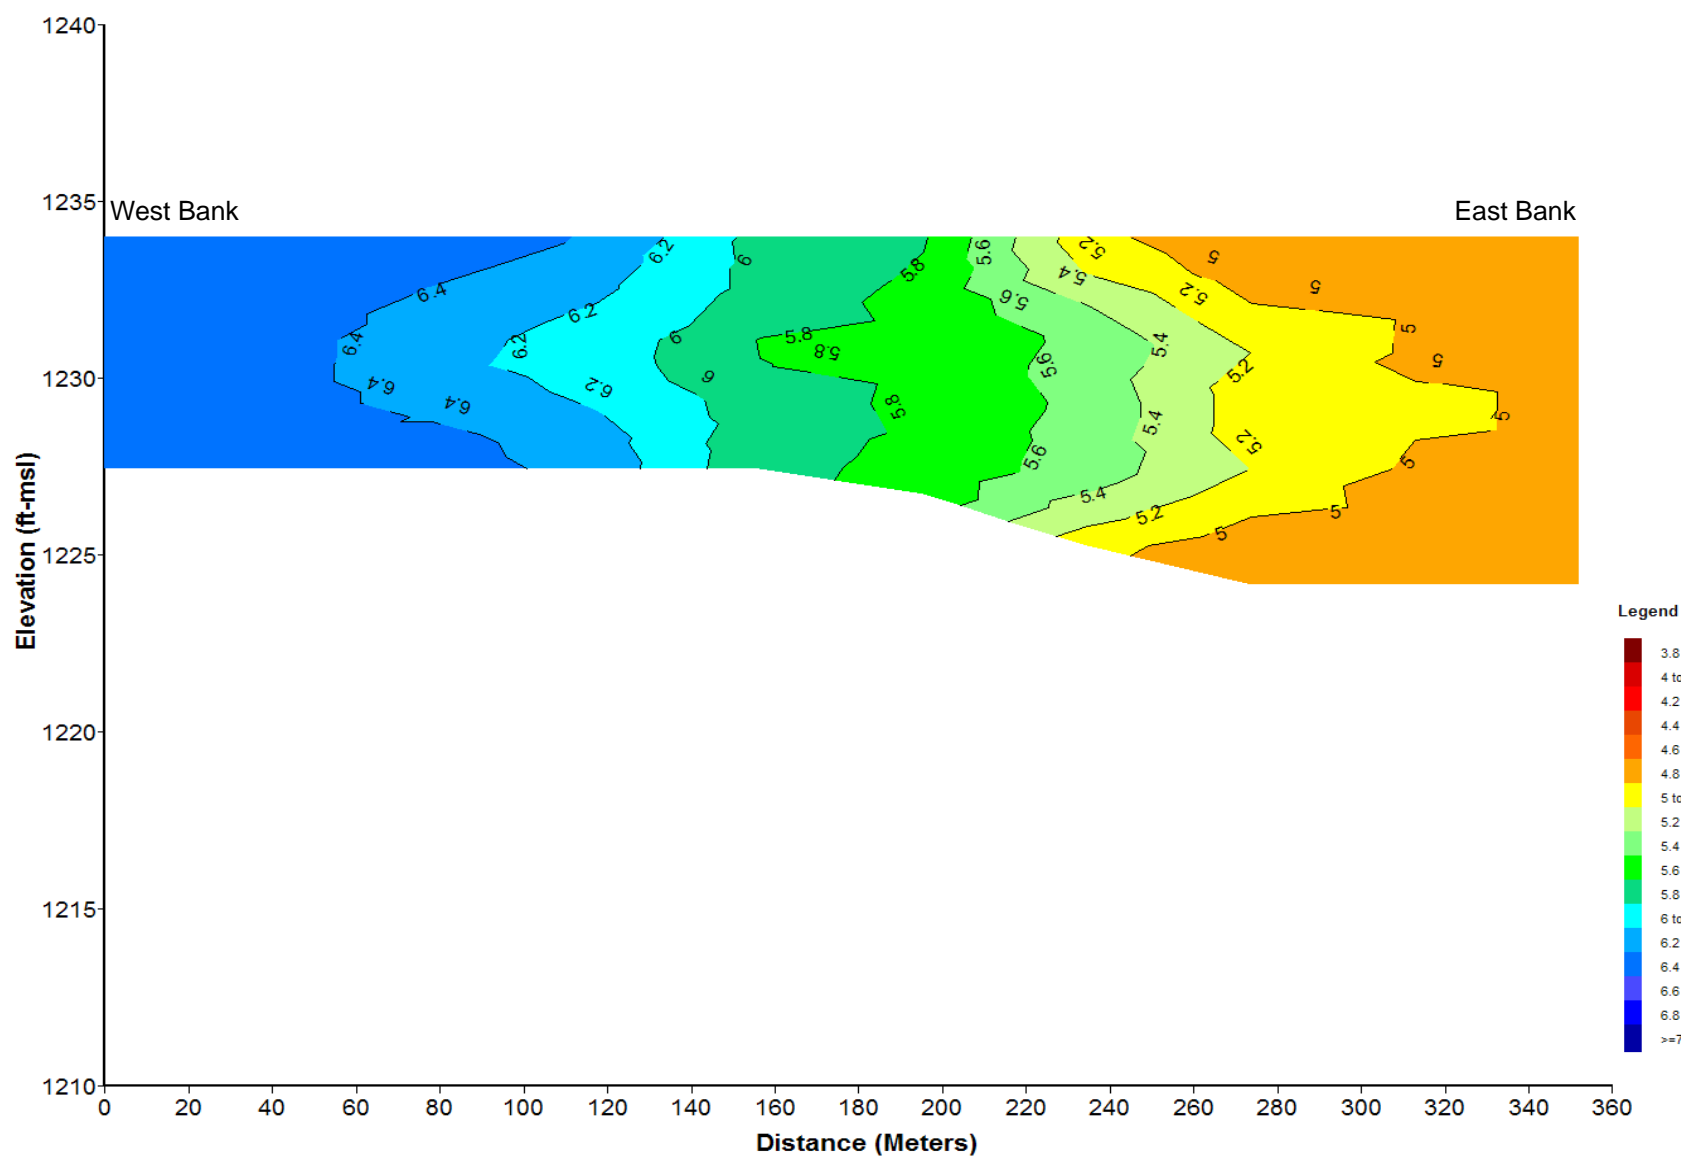
Figure 41. Contour plot depicting dissolved oxygen concentrations measured across the downstream transect (FTRTW1) on August 17, 2010.

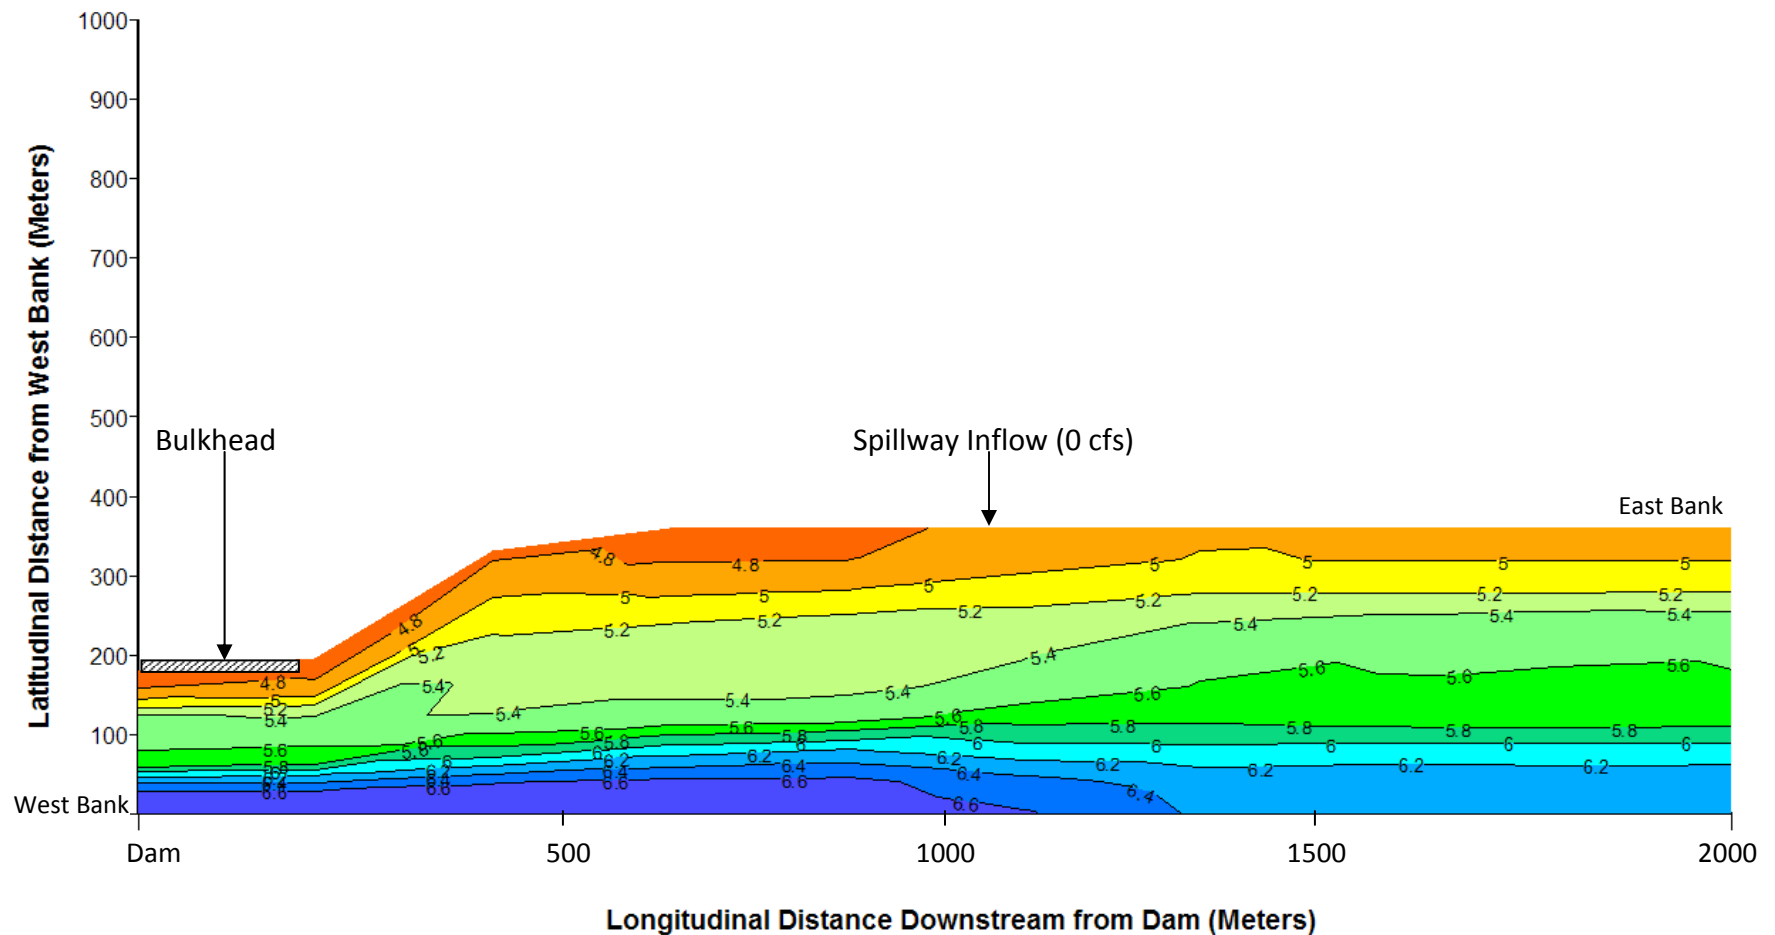
Figure 42. Contour plot of average water-column dissolved oxygen concentrations for the Fort Randall Dam tailwaters on August 17, 2010. Water-column average based on 1-meter depth-profile dissolved oxygen measurements taken at the near-dam, spillway confluence, and downstream transects. Plot is an aerial view from above with the dam to the left, flow going to the right, west bank on the bottom, and the east bank on the top (see Figure 18 for an aerial photo of the area).

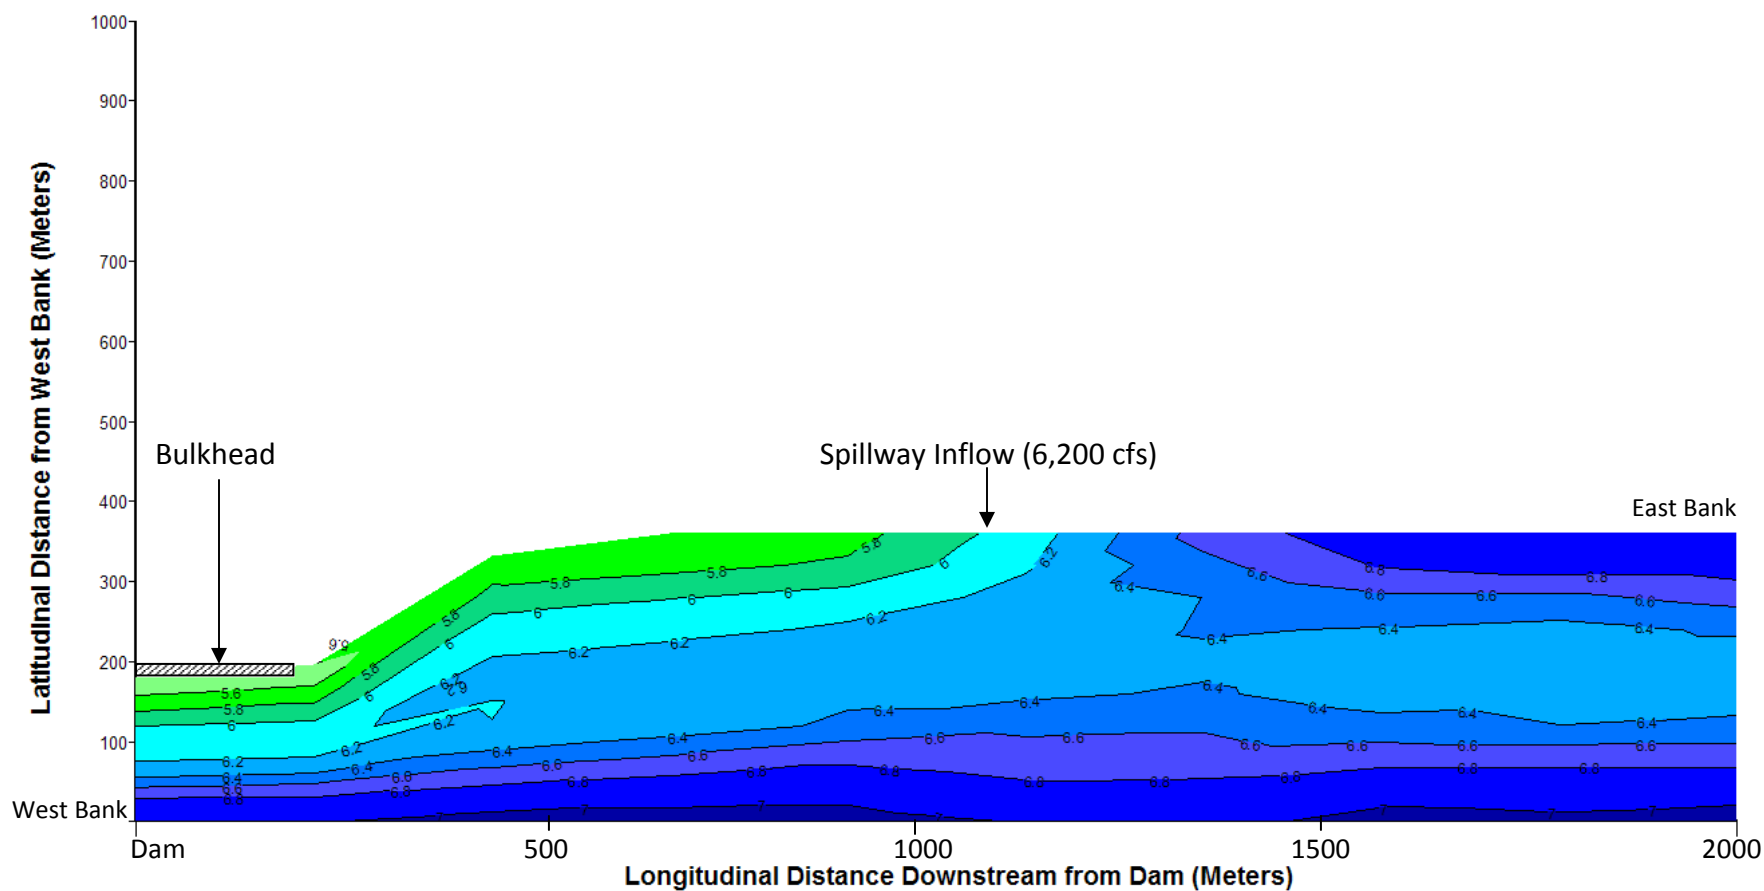
Figures 51, 52, and 53, respectively, display transect contour plots that were constructed to depict the dissolved oxygen concentrations measured across the Fort Randall Dam tailwaters at the near-dam (FTRTW3), spillway confluence (FTRTW2), and downstream (FTRTW1) sites on 26-August-2010. Figure 54 displays an aerial contour plot of the water-column average dissolved oxygen concentrations in the tailwaters based on the 1-meter incremental depth-profile measurements.

Figure 54. Contour plot of average water-column dissolved oxygen concentrations for the Fort Randall Dam tailwaters on August 26, 2010. Water-column average based on 1-meter depth-profile dissolved oxygen measurements taken at the near-dam, spillway confluence, and downstream transects. Plot is an aerial view from above with the dam to the left, flow going to the right, west bank on the bottom, and the east bank on the top (see Figure 18 for an aerial photo of the area).
